**Coromandel Wharf Upgrade
Preliminary Sediment Quality
Assessment**

Reference: 237899
Prepared for: Cranleigh
Revision: 0
10 December 2013

Coromandel Wharf Upgrade

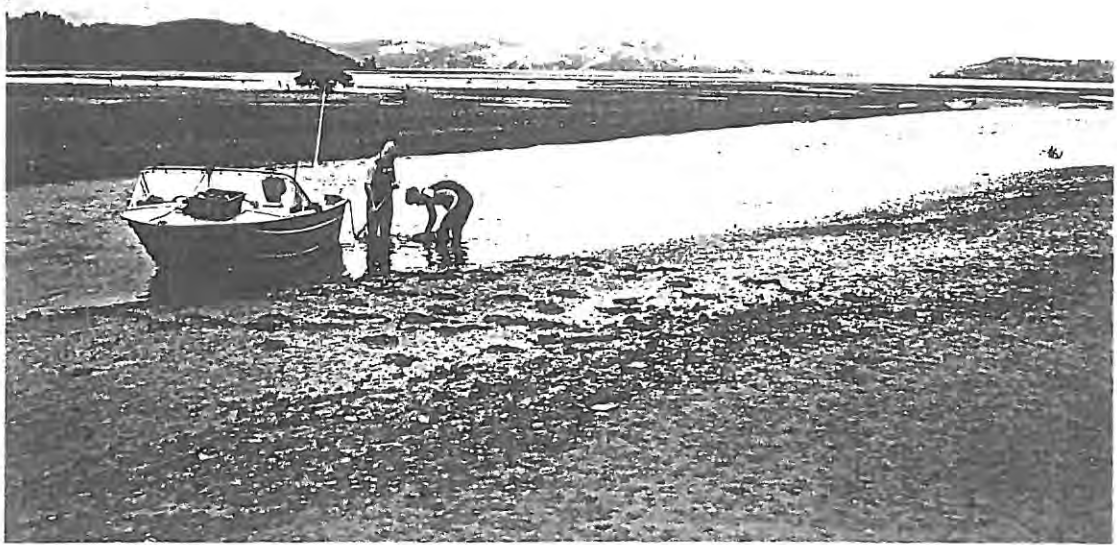
Plate 1: View to south west from site V (see Figure 2) showing soft mud (mud crab habitat) on right bank of existing channel at low tide and coarse sediments (shellfish - pipi and cockle habitat) in foreground, 18 January, 1992.

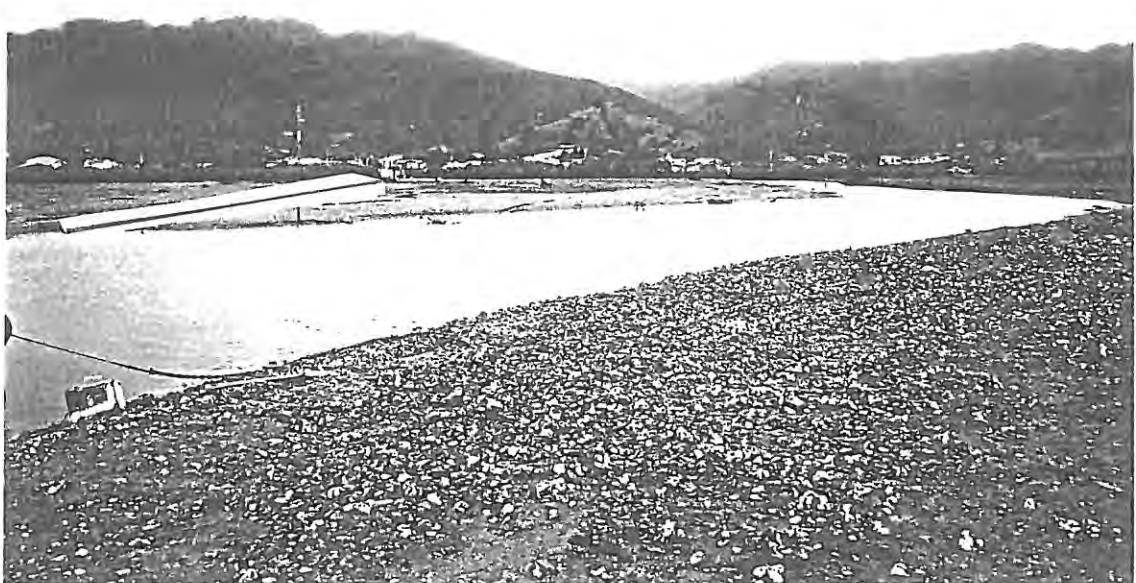
Plate 2: View to north east from site W (see Figure 2) showing Pacific Oyster habitat on left bank of low tide channel and position of proposed channel (red line overlay) 18 January, 1992.

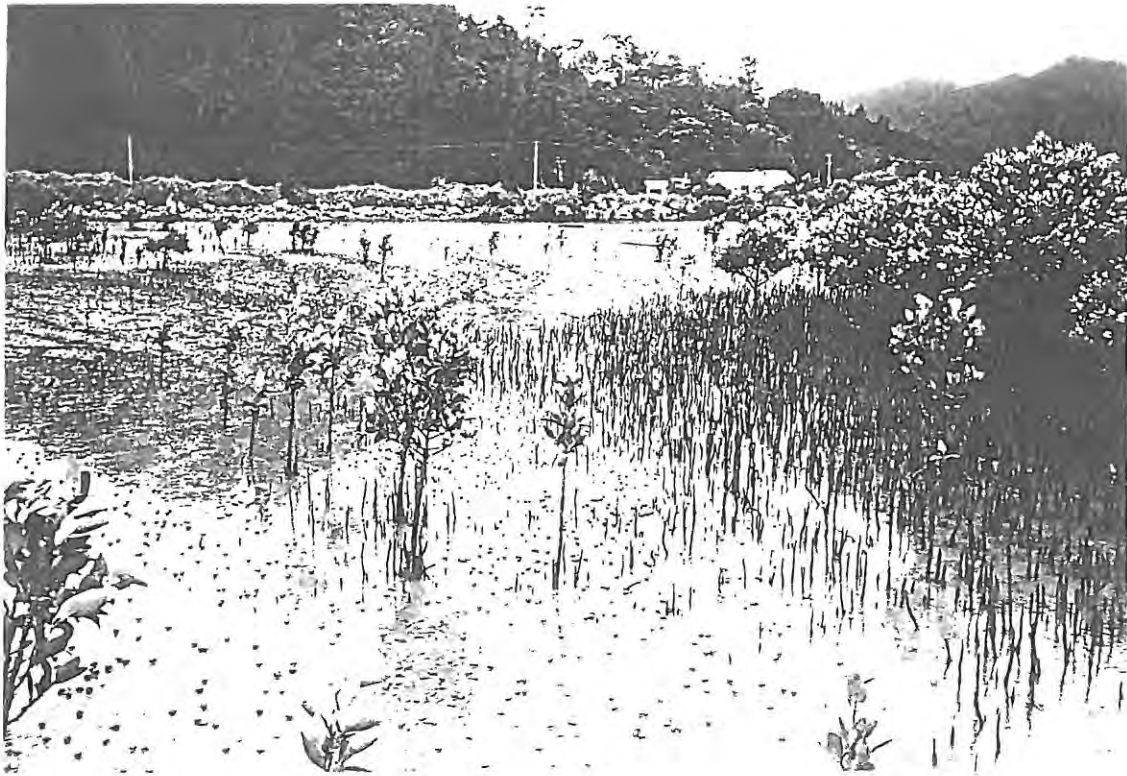
Plate 3: View to north from site X (see Figure 2) showing soft mud (mud snail habitat) in the upper inter tidal zone, surrounded by a mangrove community, 18 January, 1992.

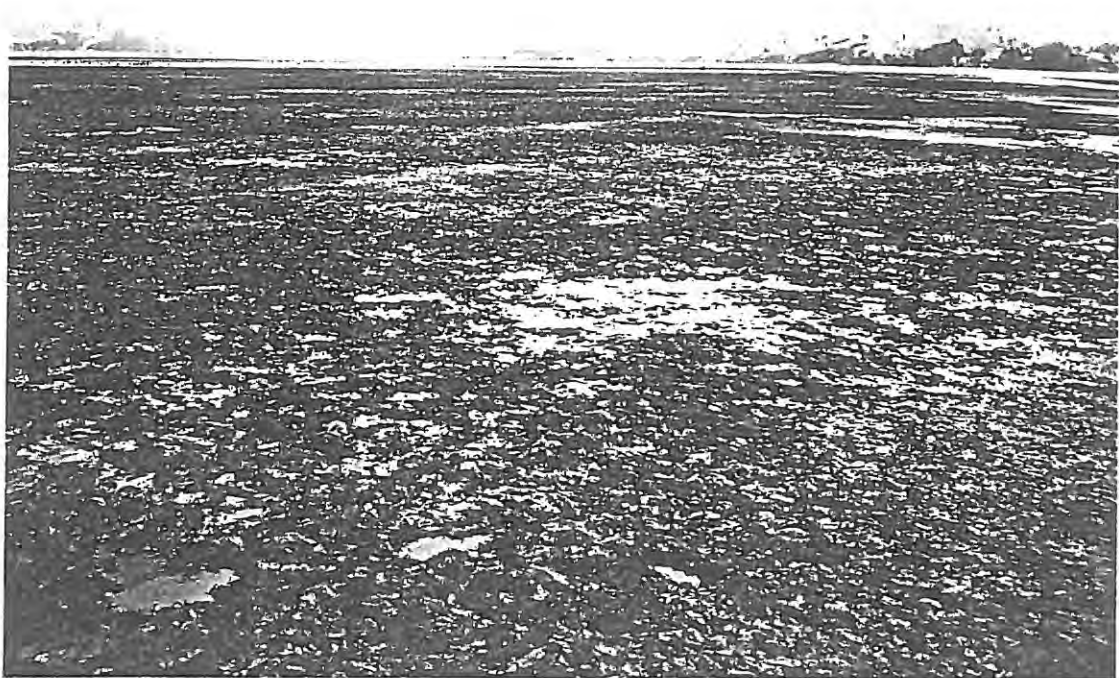
Plate 5: View to south west from site Z (see Figure 2) showing sea grass community which is exposed at low tide, 18 January 1992.

Extensive meadows of Zostera novaezealandica were present to the south west of the Whangarahi Stream mouth. Associated animals included: Alpheus socialis, Pagurus novaezealandiae, Helice crassa, Owena fusiformis, Glycera americana, Hormosira banksii, Galeolaria hystrix, Macomoana liliana, Maoricolpus roseus, Dialoma subrostrata, Amphibola crenata, Cominella adspersa, Cominella glandiformis, Melagraphia aethiops, Balanoglossus australiensis, Paphies australis, Elminius modestus, Zeacumantus lutulentus, Chione stutchburyi, and Cladophora sp.

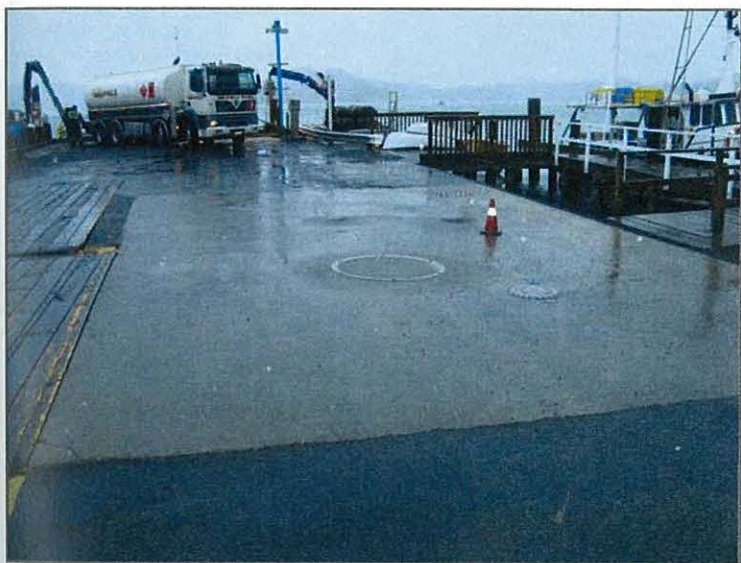
Photograph 2

View of the UST area, looking to the west.

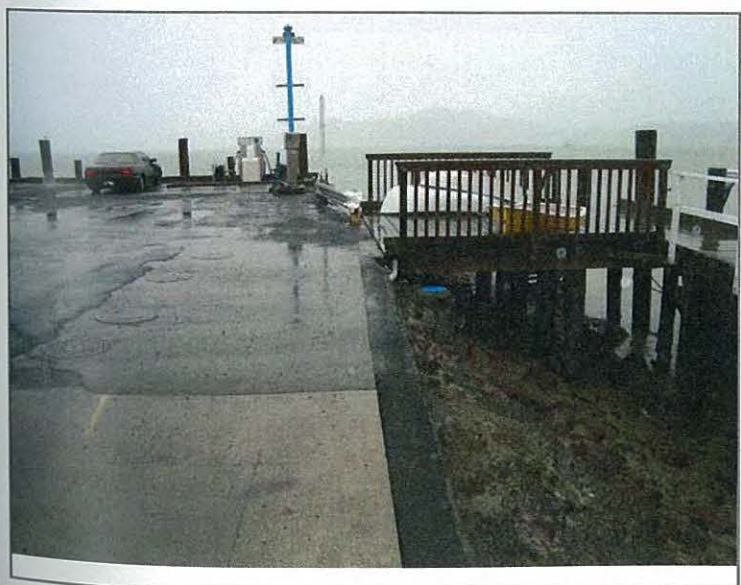
Photograph 3

View of the three-stage interceptor, looking to the west. Interceptor shutoff valve in blue to the right.

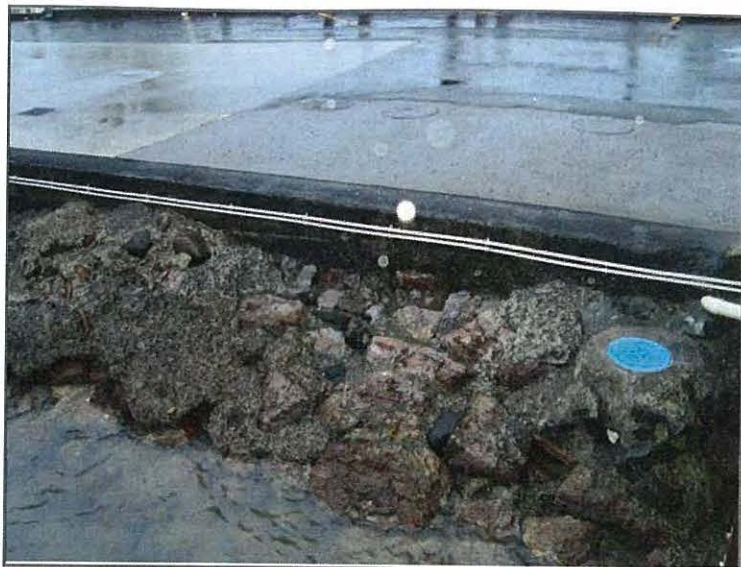
Photograph 4

Interceptor runoff and shutoff valve, looking to the north.

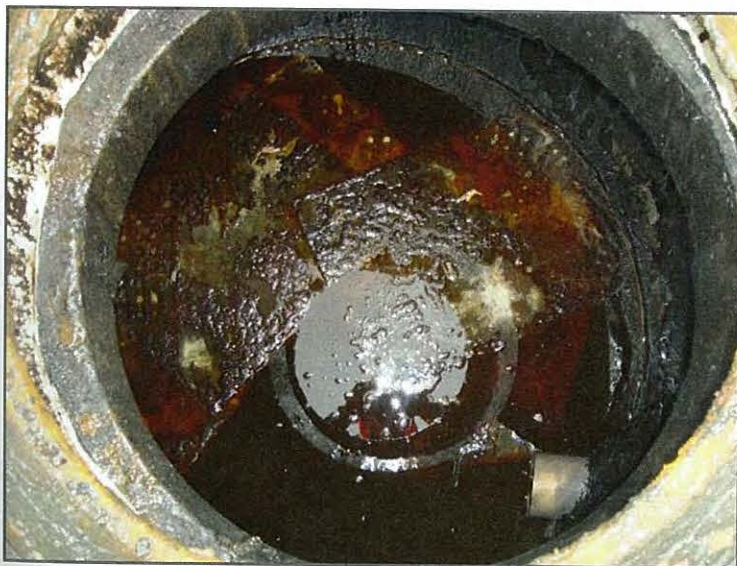
Photograph 5

View of interceptor's third stage.

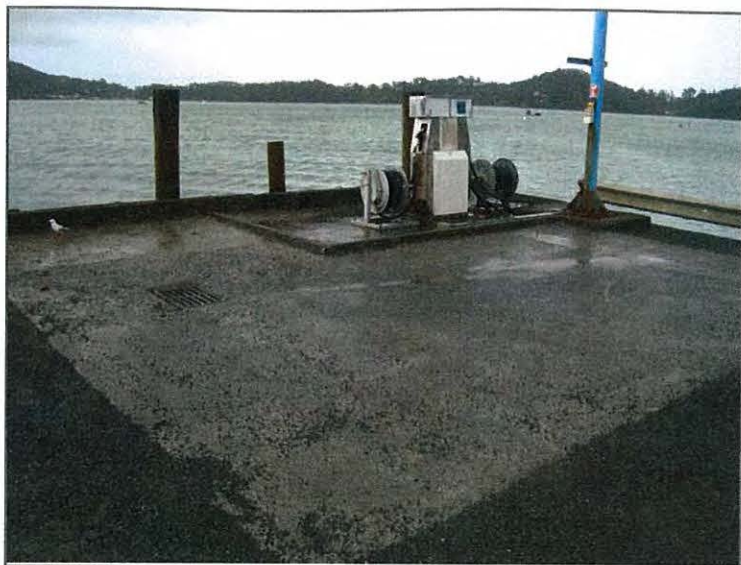
Photograph 7

View of the unloading area looking to the north-west.

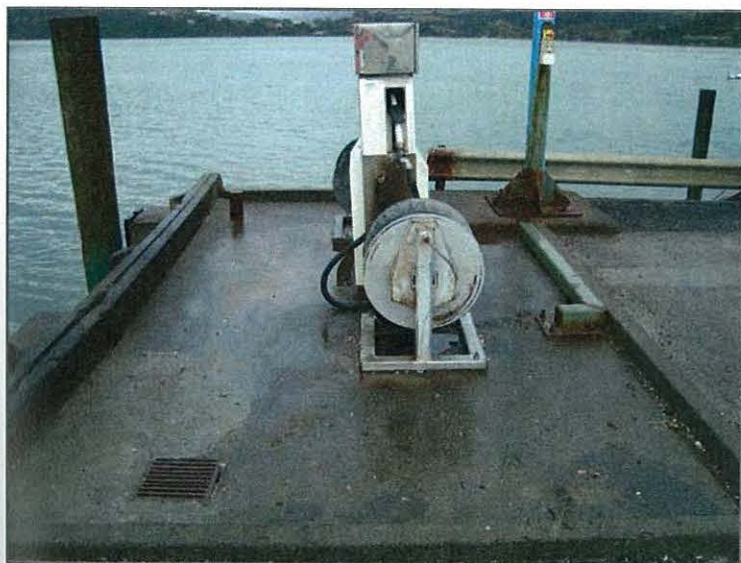
Photograph 8

Dispensers area looking to the north.

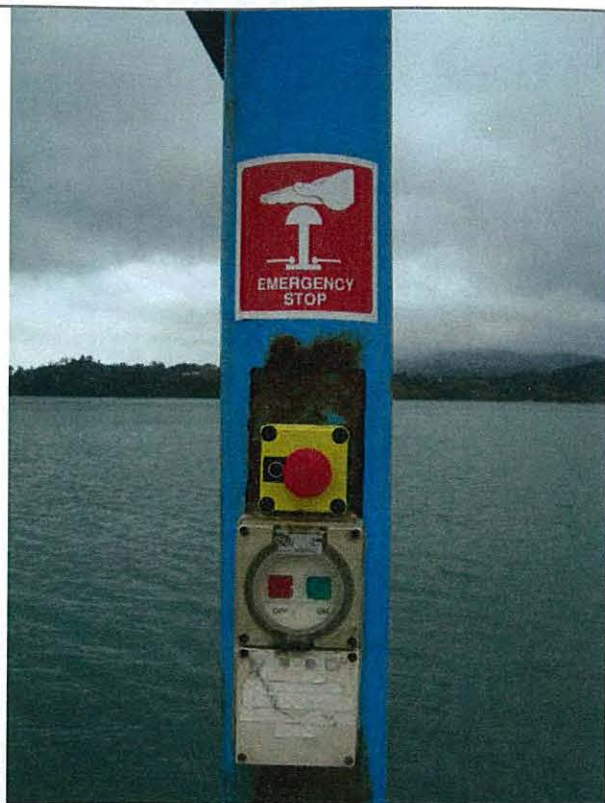
Photograph 1

Dispenser shut-off.

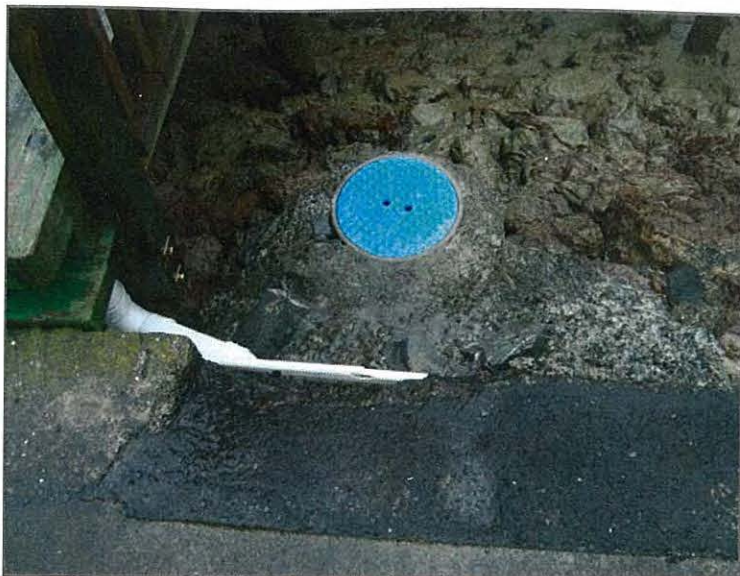
Photograph 3

Interceptor shut-off valve.

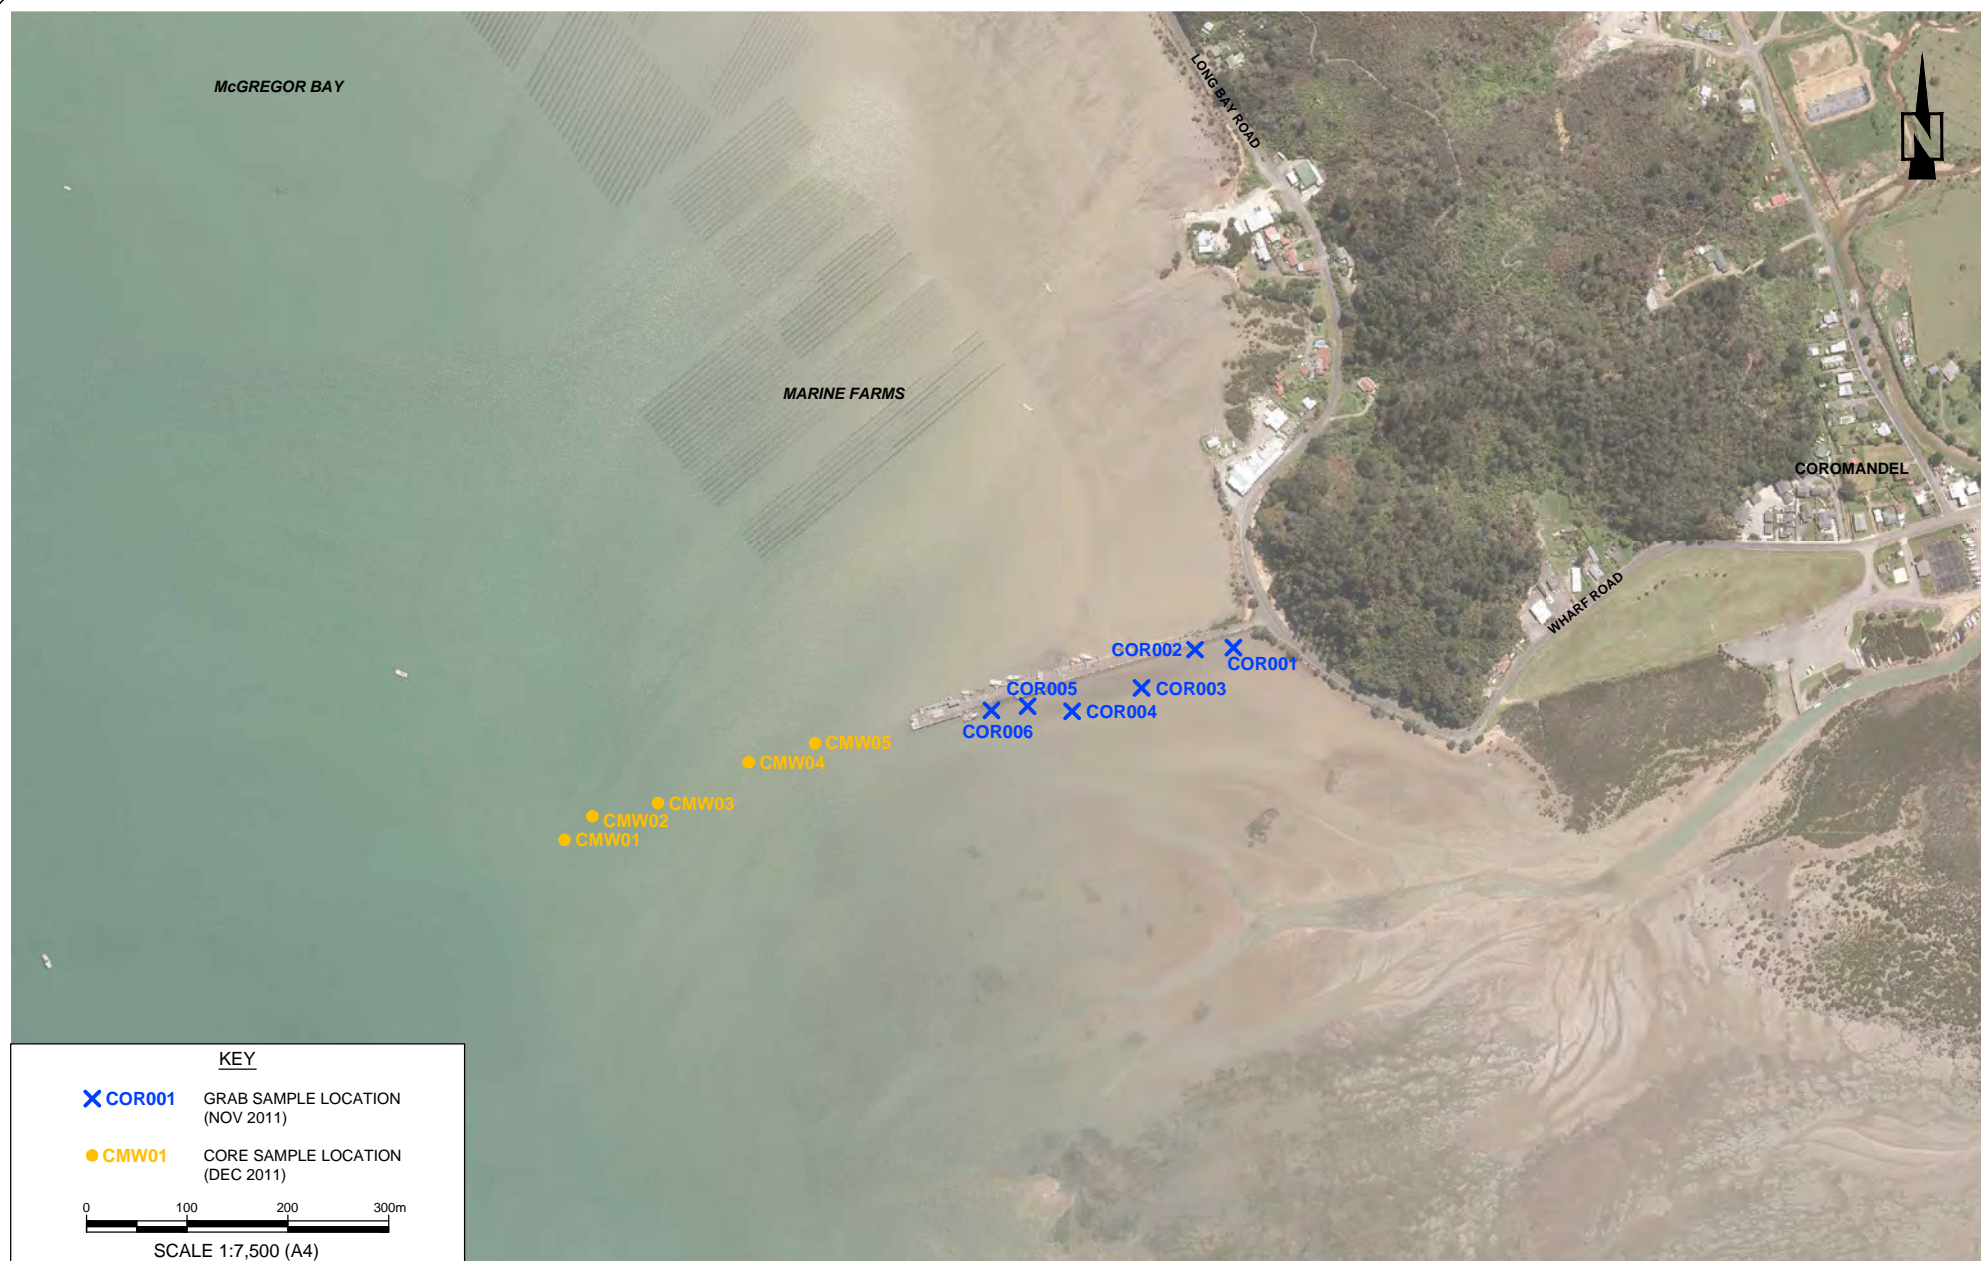
FIGURE 1 : COROMANDEL WHARF SAMPLING LOCATIONS

The discrete surface samples tested for concentrations of organotin and antimony taken near Coromandel Wharf found detectable levels of dibutyltin and tributyltin in one sample (COR-005). The dibutyltin and tributyltin concentrations were found to slightly exceed ANZECC (2000) Interim Sediment Quality Guideline ISQG-Low guideline values. However, it should be noted that these sample concentrations were not normalised for 1% Total Organic Carbon (TOC) in accordance with ANZECC (2000) protocol and as such cannot be used to assess against ISQG criteria. The effects of the natural sediment and water chemistry have effect on partitioning of organic compounds, and as such PDP have not considered these factors in their assessment.
